IMAGING VIGNETTE

Transcatheter Aortic Valve-in-Valve Implantation Complicated by Aorto-Right Ventricular Fistula

We describe the case of a degenerative, sutureless bioprosthetic valve (BPV) with deformation and stent infolding in a patient with elevated surgical risk. Following discussion among the heart team, balloon valve fracture was performed to facilitate deployment of an aortic valve-in-valve transcatheter heart valve. Post-procedural imaging demonstrated BPV frame protrusion and contained annular rupture, which required operative intervention. (**Level of Difficulty: Intermediate.**) (J Am Coll Cardiol Case Rep 2020;2:309–11) © 2020 The Authors. Published by Elsevier on behalf of the American College of Cardiology Foundation. This is an open access article under the CC BY license (<http://creativecommons.org/licenses/by/4.0/>).

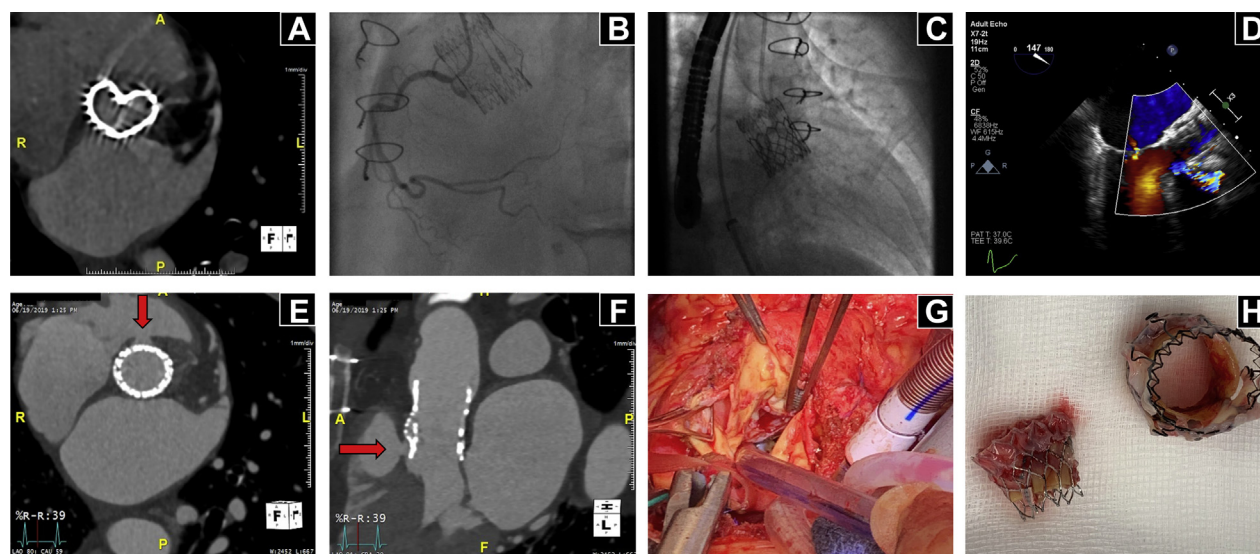
FIGURE 1 CT Demonstrates Stent Infolding, Distortion, and Collapse of Perceval Sutureless Valve

(A) CT imaging demonstrates stent infolding, distortion, and collapse of Perceval Sutureless valve. (B) Left anterior oblique view of a Perceval Sutureless valve during right coronary angiography. (C) Orthogonal view of a successful Sapien S3 valve-in-valve implant. (D) Mid-esophageal long-axis view on TEE demonstrates a fistulous connection (white arrow shows color Doppler flow) between the right coronary cusp and right ventricle. Axial (E) CT imaging of well-deployed valve-in-valve with fistulous connection (white arrow) confirmed by contrast leak (F). This is also demonstrated by 3-dimensional CT reconstruction (white arrow). (G) Resternotomy for surgical AVR. (H) Sapien 3 (left) and Perceval Sutureless (right) valves retrieved perioperatively. AVR = aortic valve replacement; CT = computed tomography; TEE = transesophageal echocardiography.

fistulous connection between the left ventricular outflow tract and right ventricle on both TEE (**Figure 1D**, **Video 3**) and left ventriculography (**Video 4**). Hemodynamic stability was maintained throughout the procedure, and the contained rupture was concluded to be benign. After THV implantation, contrast-enhanced CT (2-dimensional [2D] and 3D reconstruction) confirmed a clear contrast leak at the level of the aortic neosinuses and the waist of the THV into the right ventricular outflow tract through the valve frame (**Figures 1E and 1F**). Within 12 h, the patient's hemodynamic status acutely deteriorated and required urgent re sternotomy as an inpatient (**Figure 1G**). The THV and original Perceval sutureless valves were retrieved and the aortic valve and root replacement procedures were redone (**Figure 1H**). The **Central Illustration** depicts the transcatheter heart valve inside the Perceval bioprosthesis and the anatomical position of the fistula. Perceval valve degeneration treated with valve-in-valve THV implantation has been previously reported (1). However, this is the first report of fistula formation following valve-in-valve transcatheter aortic valve replacement in this valve, despite appropriate sizing. There are limited data, but the ENCORE (European Contained Rupture Registry) would support a benign course of initially asymptomatic contained ruptures. This contained rupture was hypothesized to have occurred following THV expansion as a result of BPV frame protrusion and was associated with late hemodynamic collapse. Further experience is required particularly when performing valve-in-valve for structural degeneration of sutureless valves, despite good outcomes in published registry data (2,3).

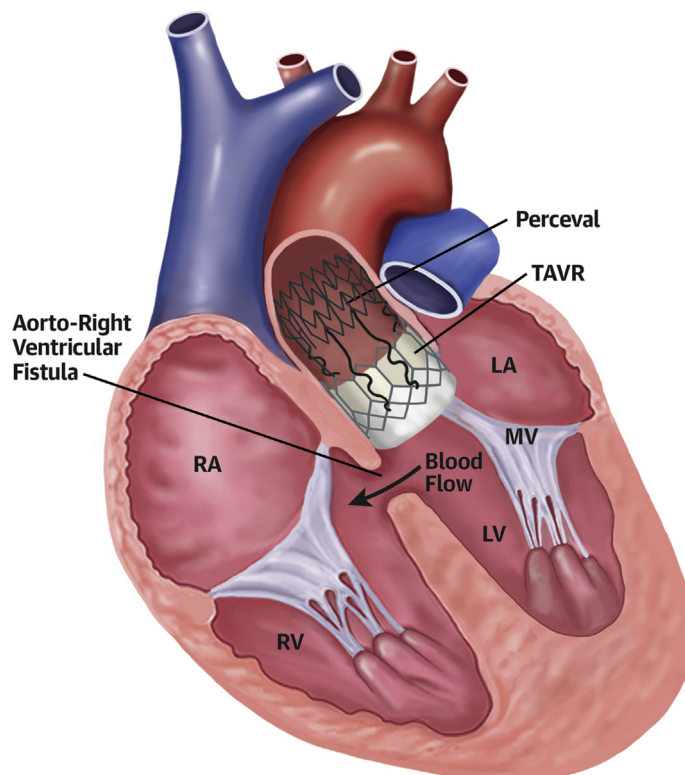
CENTRAL ILLUSTRATION Image of the Patient's Cardiac Anatomy

This demonstrates the heart in cross section, with the transcatheter heart valve (TAVR) implanted with the Perceval sutureless valve. The aorto-right ventricular fistula has created a shunt from the left ventricle (LV) to the right ventricle (RV). LA = left atrium; MV = mitral valve; RA = right atrium.
